# Allied-Axis

THE PHOTO JOURNAL OF THE SECOND WORLD WAR

# Contents

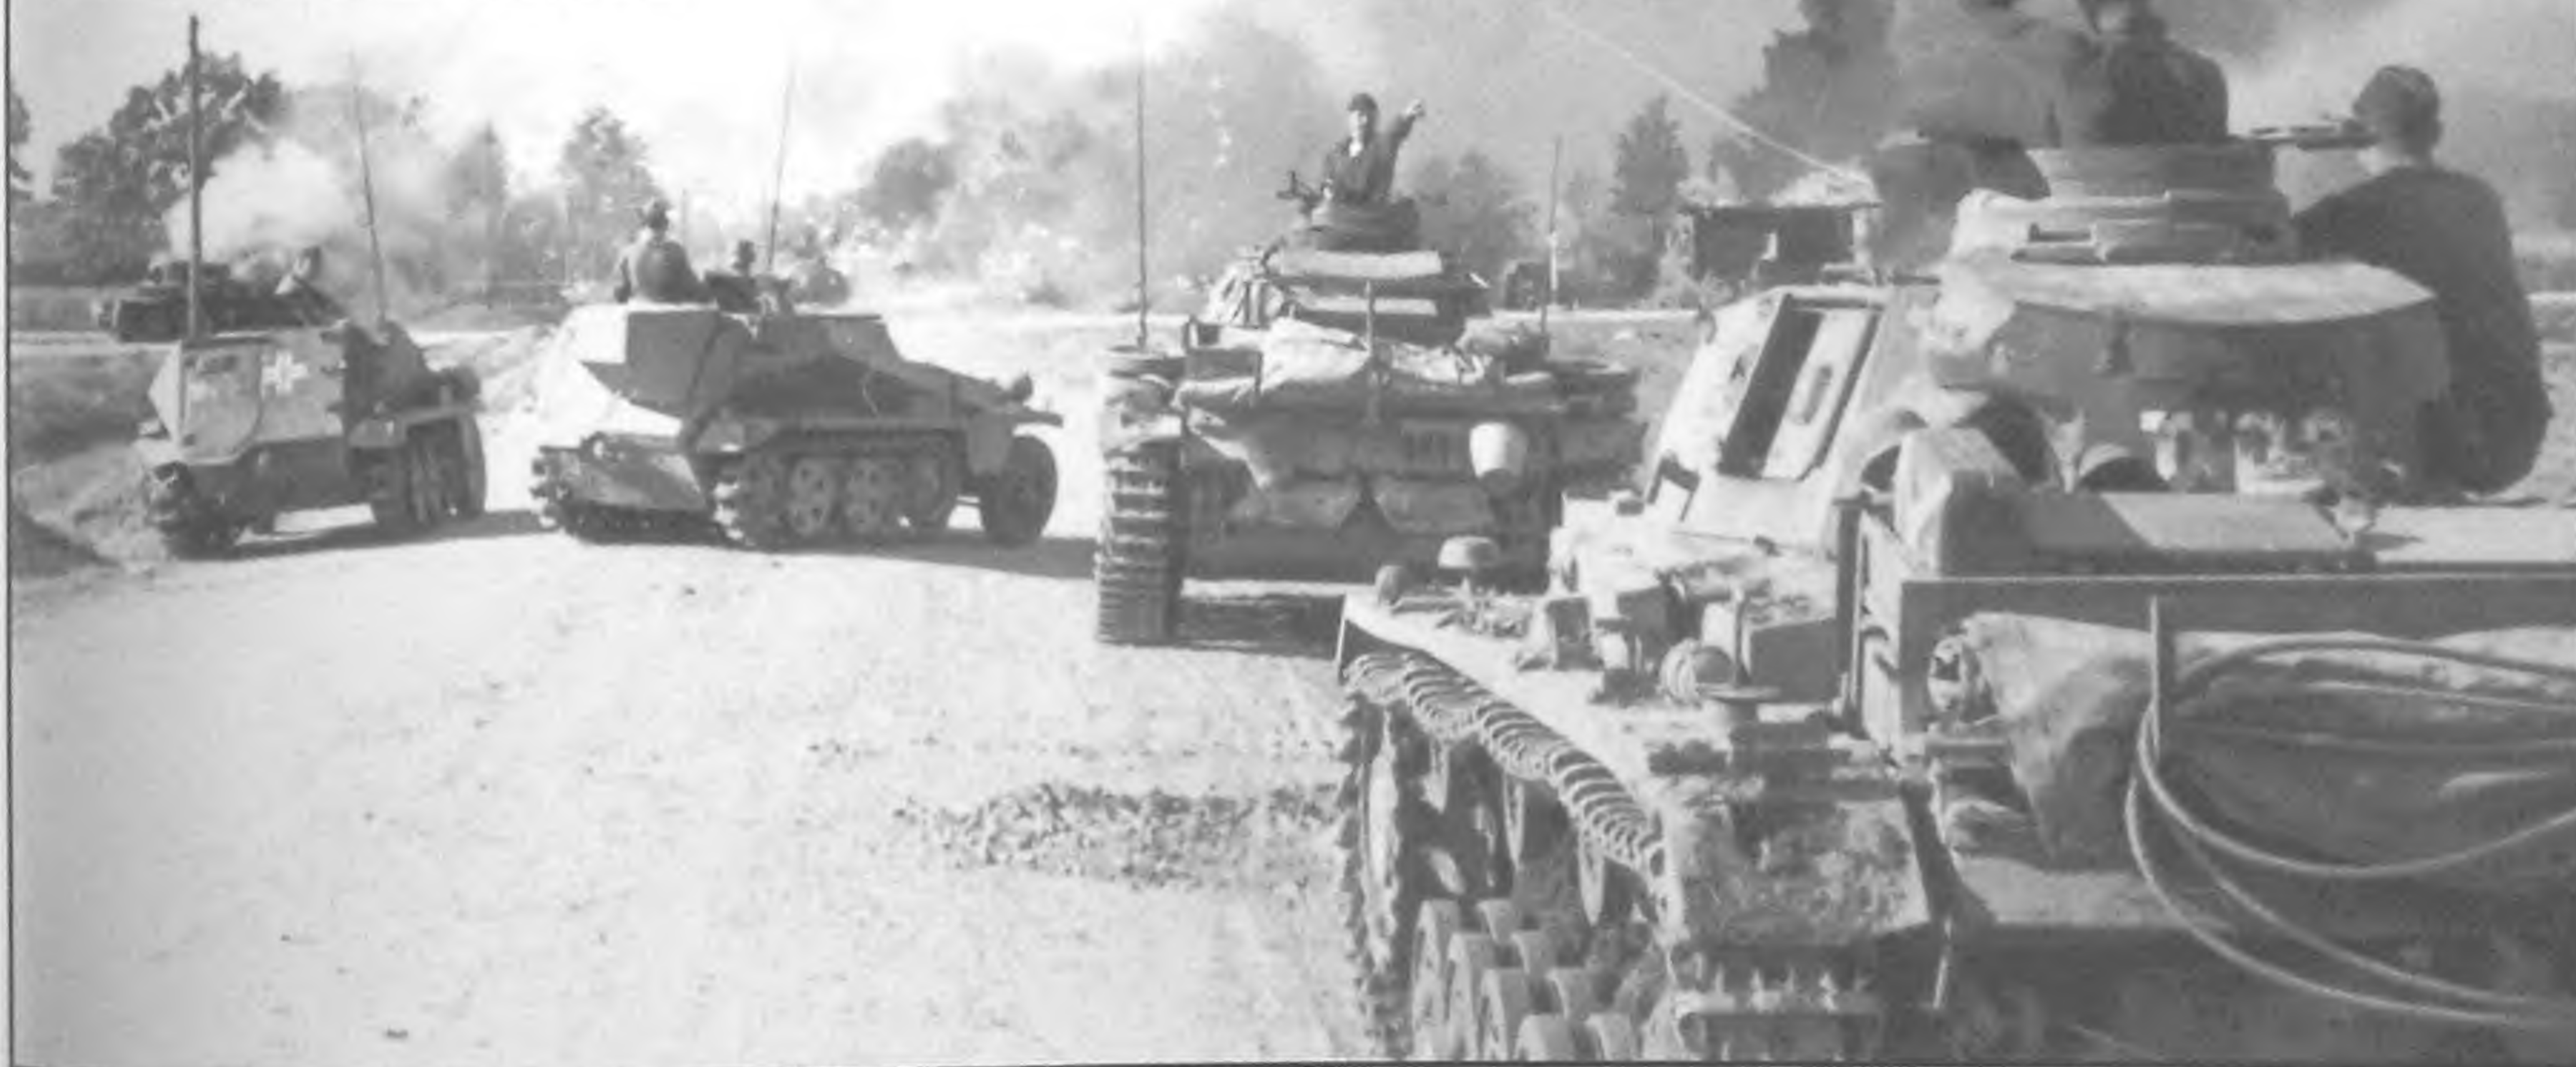
Above: two SdKfz. 250's wait outside a Russian village for armored elements to arrive. The purpose of the Aufklärungs company was to determine points of resistance and direct the proper forces towards them. Both these vehicles are the 250/3 variant. This was known as the leichte Funkpanzerwagen and

was used to transport the FuG7, FuG12 or a combination of the FuG7 and FuG8. All used the distinctive two-meter antenna. The vehicle in the center has an interesting unit-made stowage box attached to the rear armored panel. (BA)

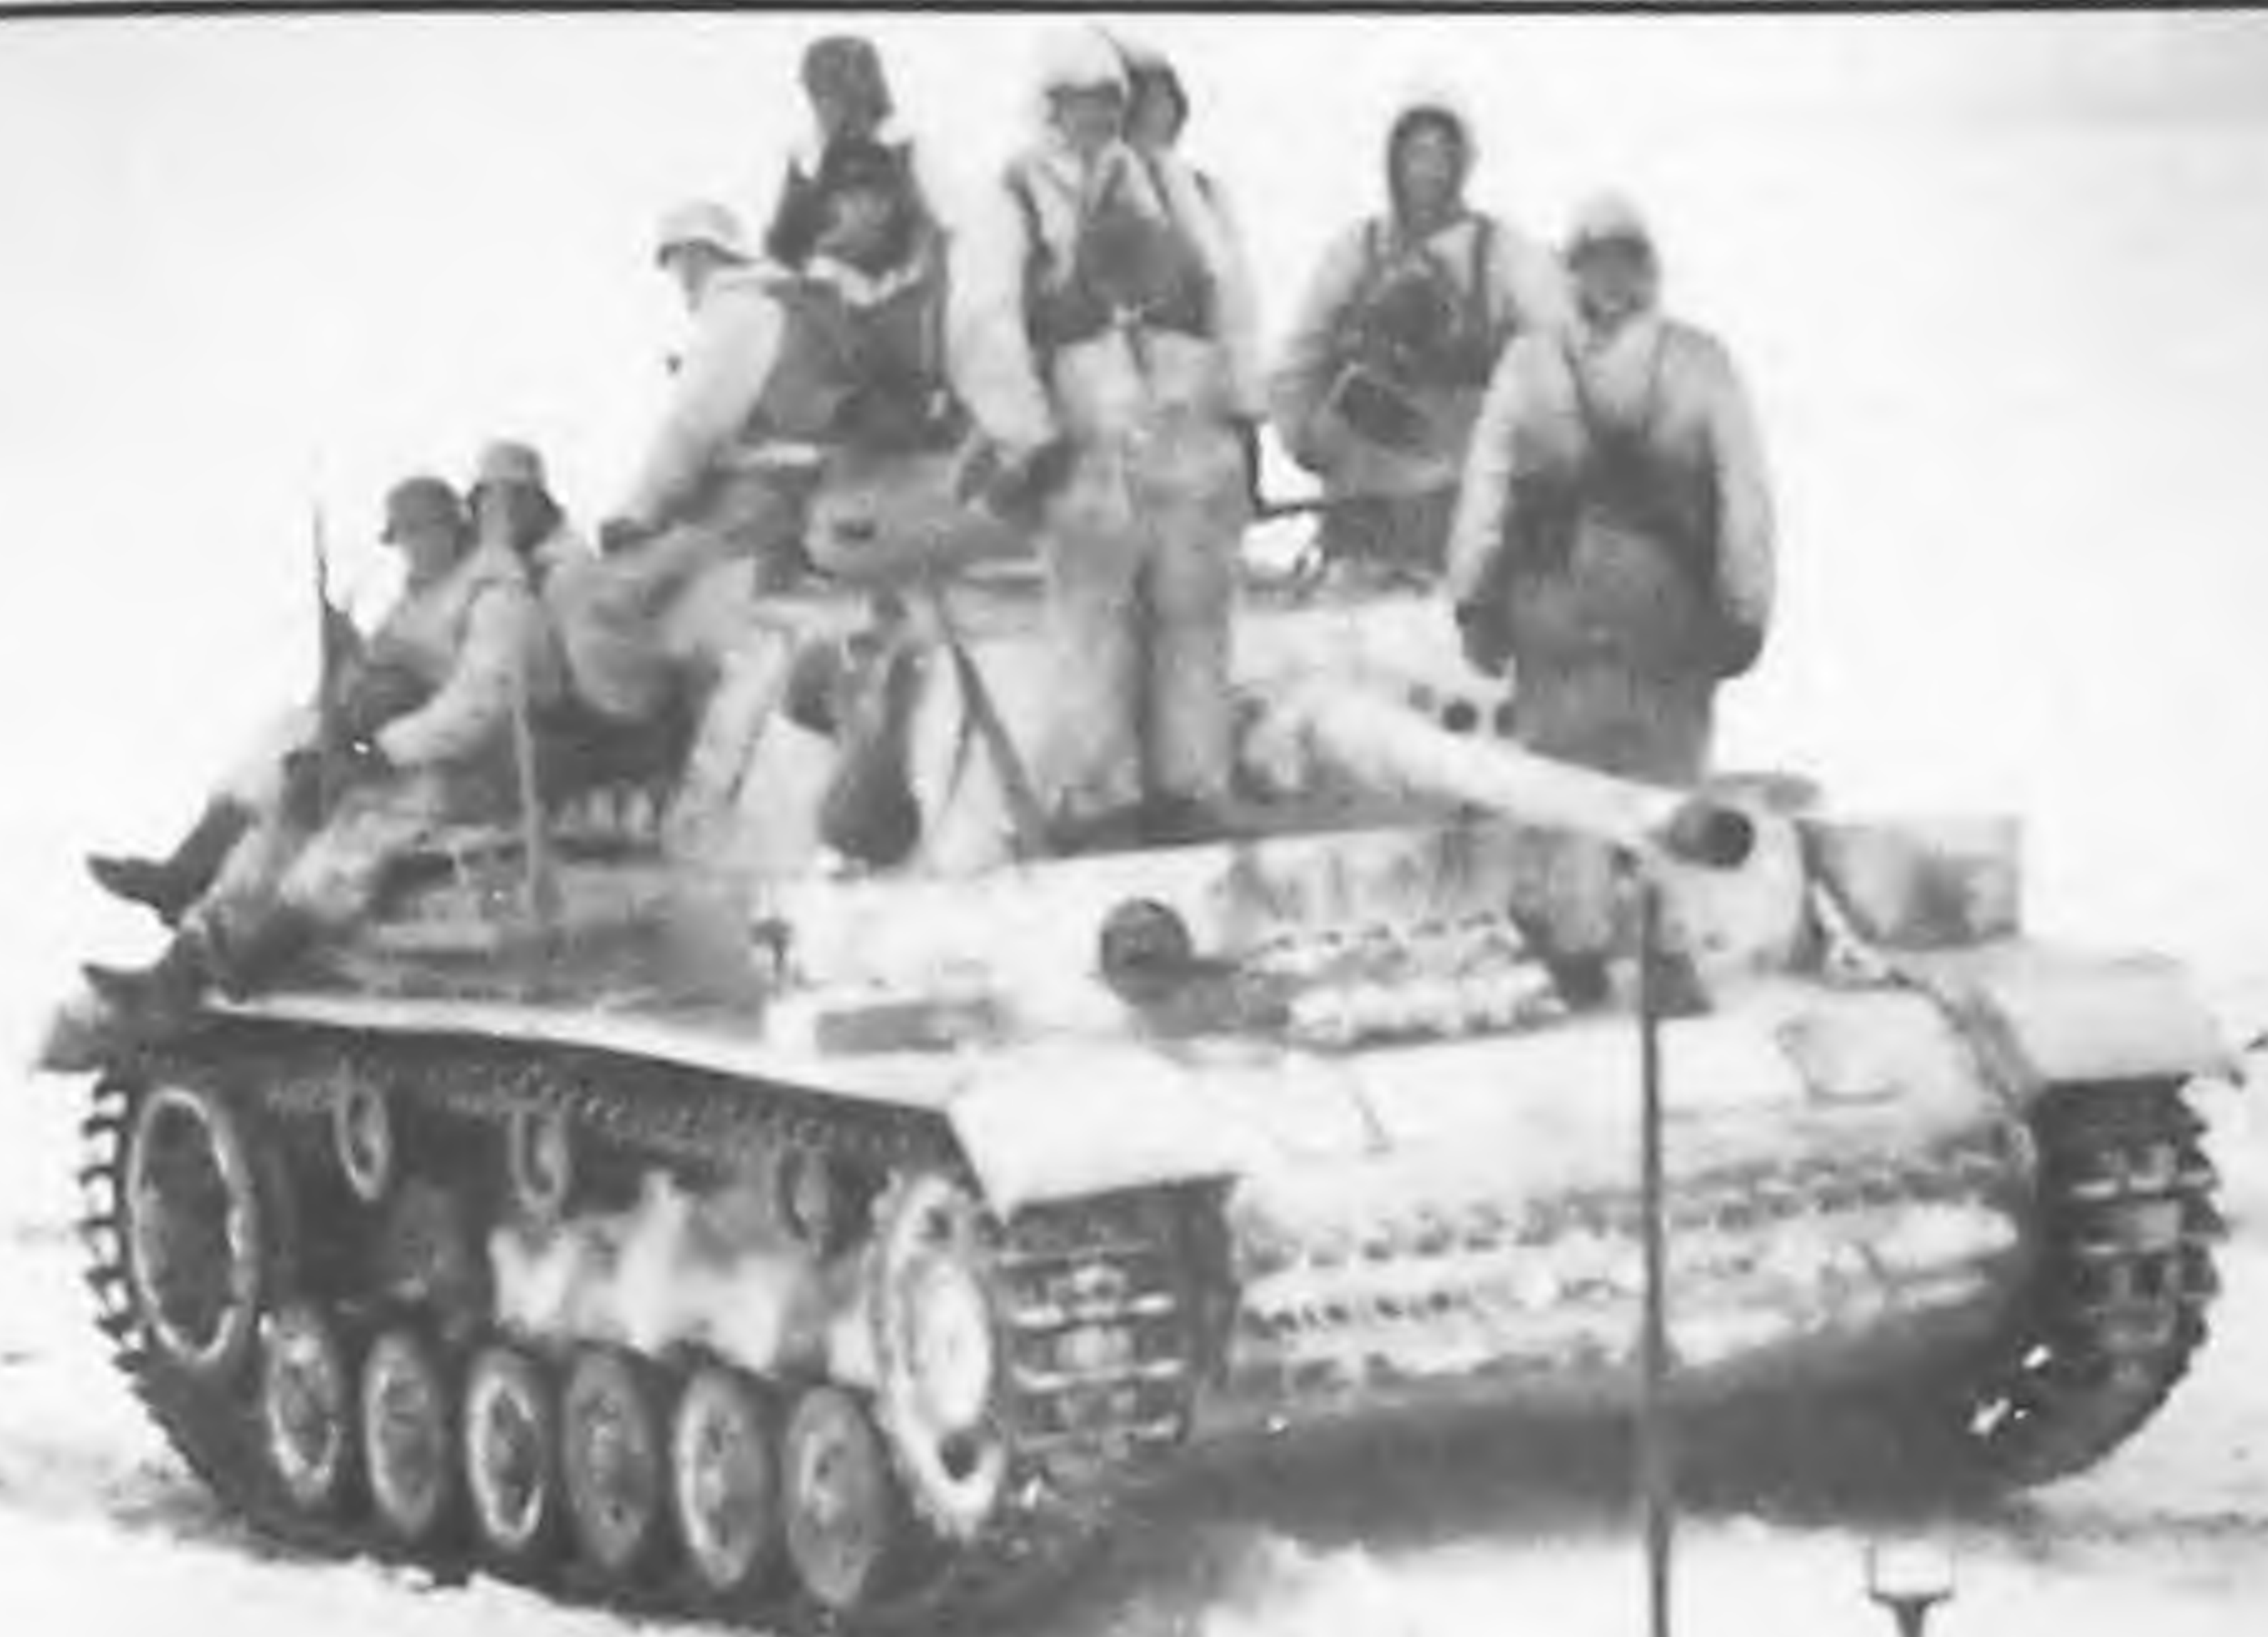
A Sd.Kfz. 250/1 of the SS-Panzer Grenadier Division Leibstandarte advances towards the city of Kharkov in early March of 1943. This vehicle was part of SS-Pz.Gren.Rgt. 1, which after crossing the Msha River, attacked the city from the north. This picture was taken in the village of Dergatschi, a sizable obstacle on the road into the city. (BA)

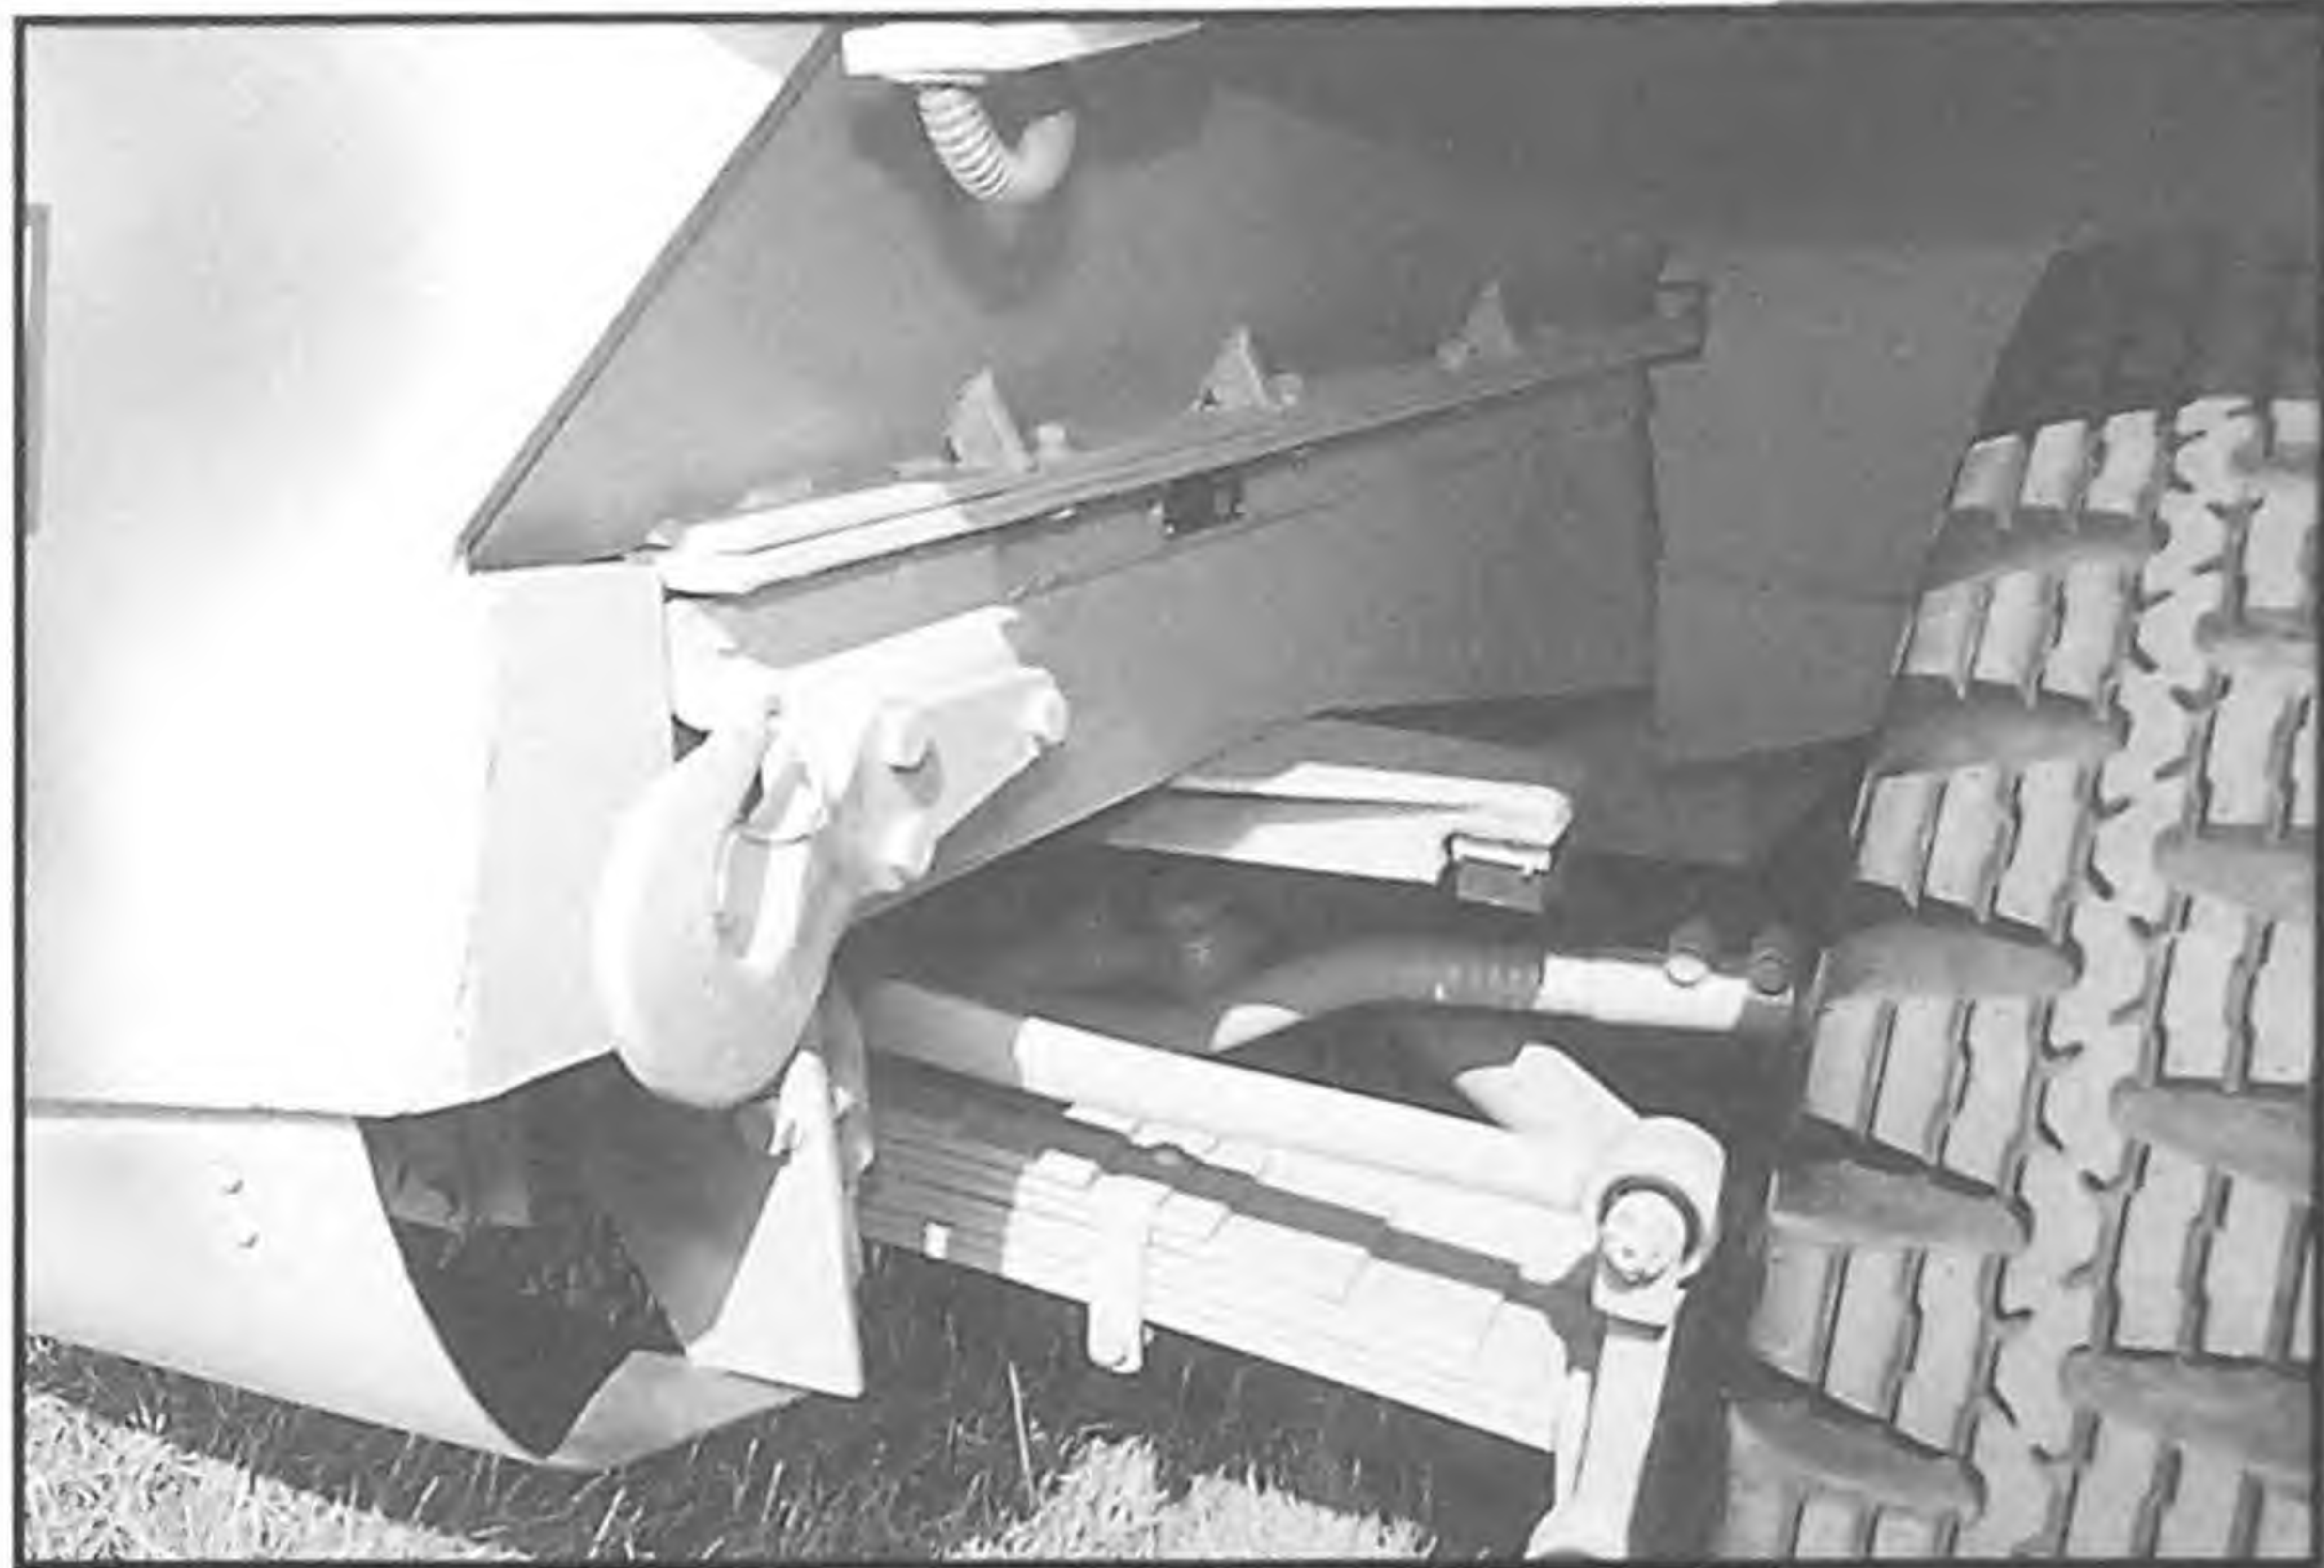
**Top left:** This restored Sd.Kfz 250 has been appropriately marked as a vehicle of an armored recon unit. In this case, one from the 2nd SS Panzer Division "Das Reich." **Top right and above left:** Close-up views of the front suspension showing the leaf construction of the front axle. The front tow hooks and

their mounting positions are also visible. Note the steel brush guard mounted under the front end of the vehicle. This was not an armored panel, but was only present to guard the suspension. **Above right:** The installation of the pick on the right front fender.

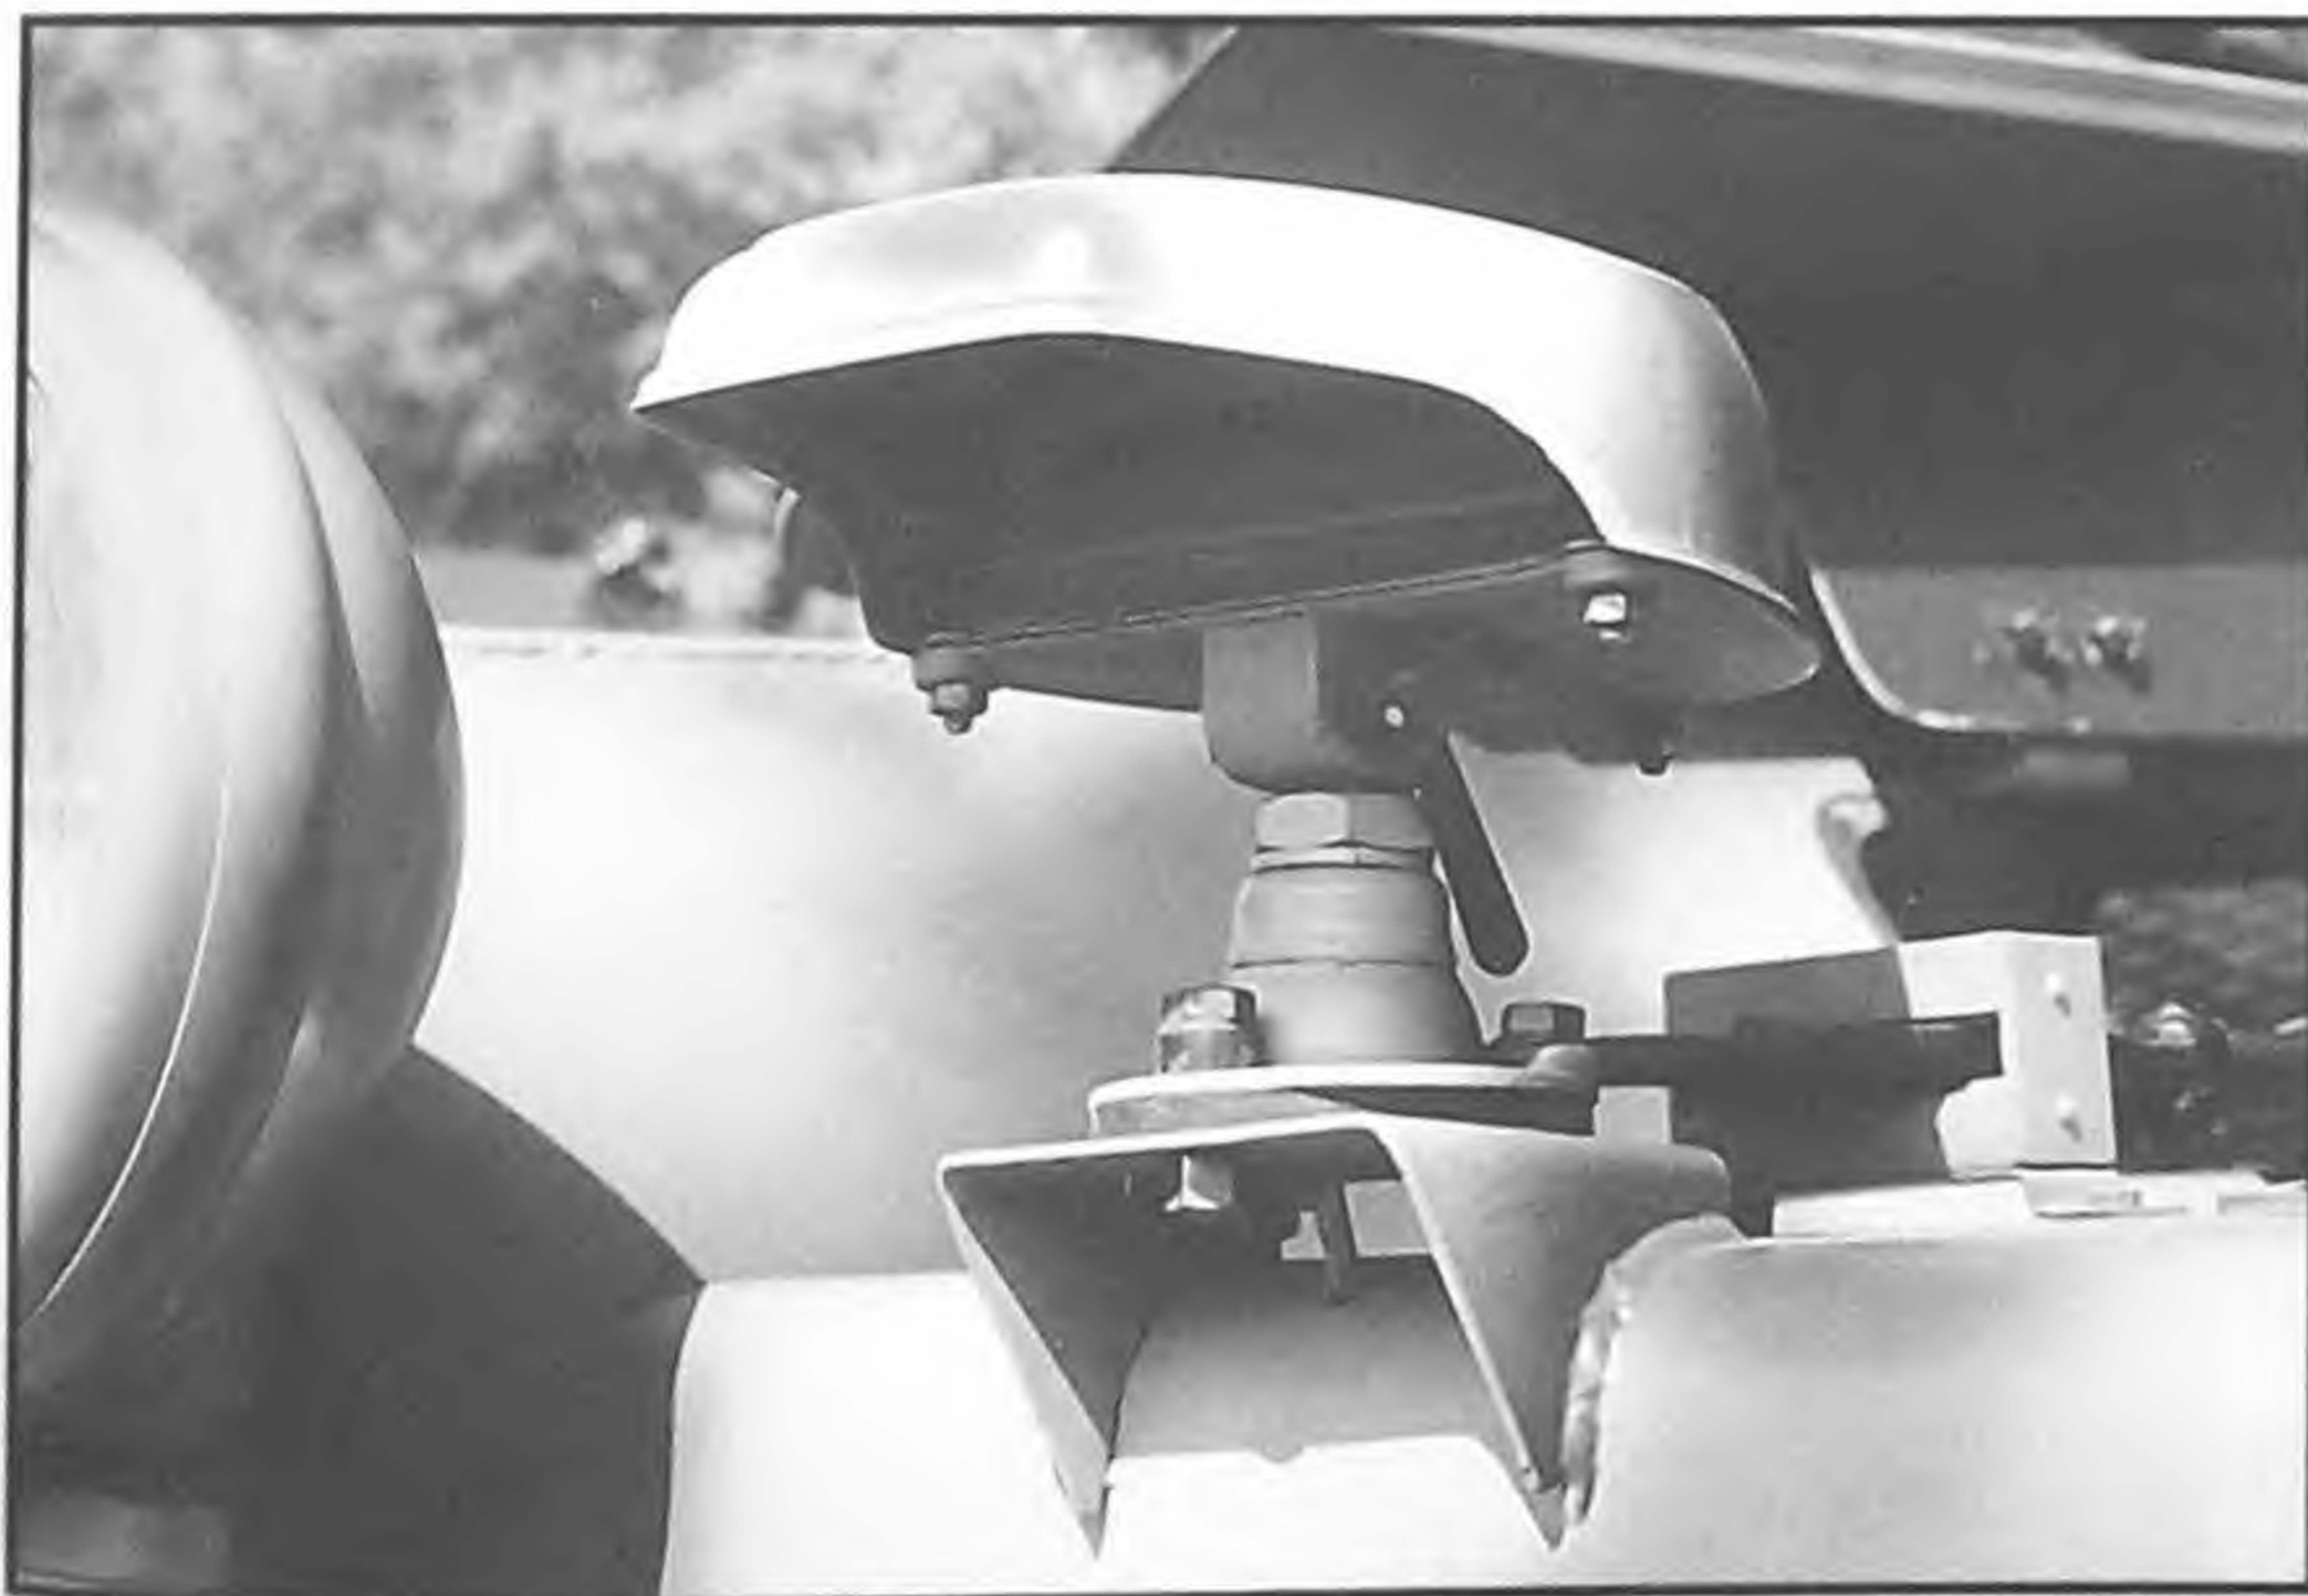
Top left: An overall view of the left fender showing the layout of the Notek light, distance marker and wire cutters. Above left: A close-up of the Notek light and its mount. Note the weld bead where the mount meets the fender. Above right: Another close-up of the distance marker, this time on the left side fender. This photo provides a good perspective of the mount of the rearview mirror mounted on the marker rod.
